**ANNUAL REPORT FOR MONITORING OF SUSPENDED
SEDIMENT CONCENTRATIONS AND TURBIDITY DURING
THE 2023 WATER YEAR IN MCCLOUD CREEK,
HUMBOLDT COUNTY, CALIFORNIA**

**Pursuant to:
Monitoring and Reporting Program (MRP)
Order No. R1-2020-0001**

Green Diamond Resource Company
Korbel, California

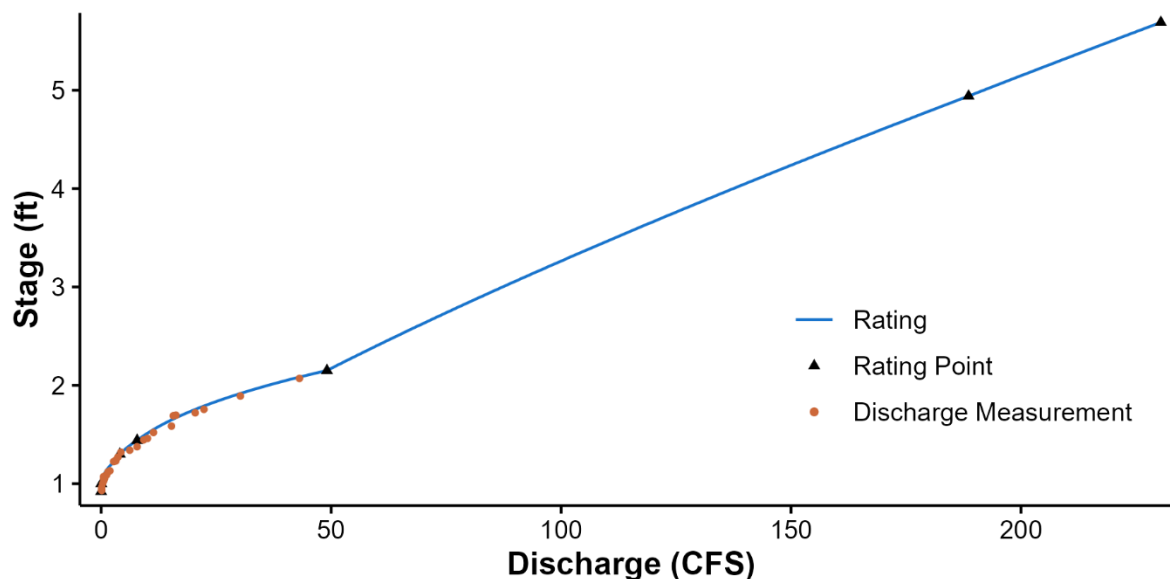
Figure 3. Discharge-stage rating including the associated rating points and measurements used for the 2023 WY.

During the 2023 WY, GDRCo personnel collected 30 water velocity measurements using the Price Pygmy flow meter. Using Aquatic Informatics' Rating Review Tool (Aquarius, 2022), coincidental stages were taken with discharge measurements and plotted to create a rating curve for the 2023 WY (Figure 3). Twenty-nine of the thirty measurements were used to verify the stage-discharge relationship used during this water year, as one measurement was poor quality due to low-streamflow conditions. The effective rating period begins on October 1, 2021 in which the same relationship was used between stage and discharge during this time since there were no major physical changes to the channel control of the monitoring unit.

Derived discharge values above the maximum measured stage of 2.12 ft for the rating period were extrapolated using the Flow Transference Method (FTM) with discharge data from the South Fork Elk River provided by Humboldt Redwood Company. Prior to water year 2022, measuring a high-water discharge above this stage has been limited by technician's ability to cross the SF Elk River which is unsafe at higher flows. Previous extrapolations of the rating curve simply extended the known curve to the maximum recorded stage value to produce a derived discharge. That extrapolation method yielded unusually high discharge values in excess of 1000 CFS which would begin to exceed discharge measurements from the Humboldt Redwood Company South Fork Elk River gaging station. The FTM yields a more realistic discharge value that is consistent with what would be expected of a watershed the size of McCloud Creek. These data should be used and viewed with caution without additional empirical support.

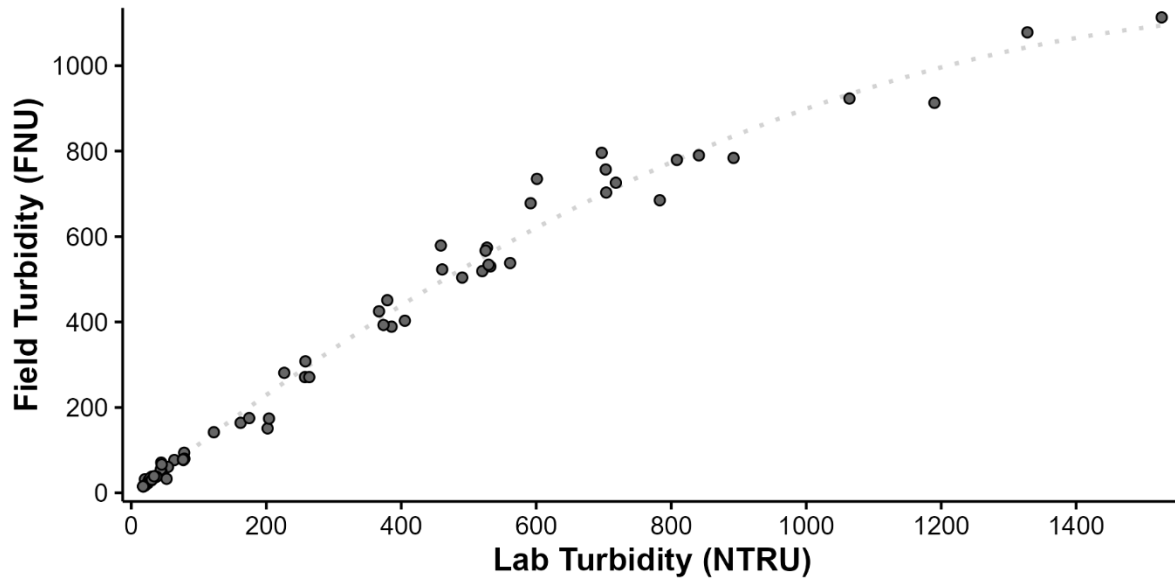
Figure 5. Relationship between coincident lab turbidity measurements (NTRU) and field turbidity measurements (FNU) collected at the McCloud Creek TTS station during the 2023 WY.

A relationship between the lab and field turbidity measurements was analyzed to develop a regression equation (Figure 5). This regression equation was then applied to lab sample

turbidities to assist in reconstructing missing field turbidity, smoothing erratic values, or verifying turbidity spikes.

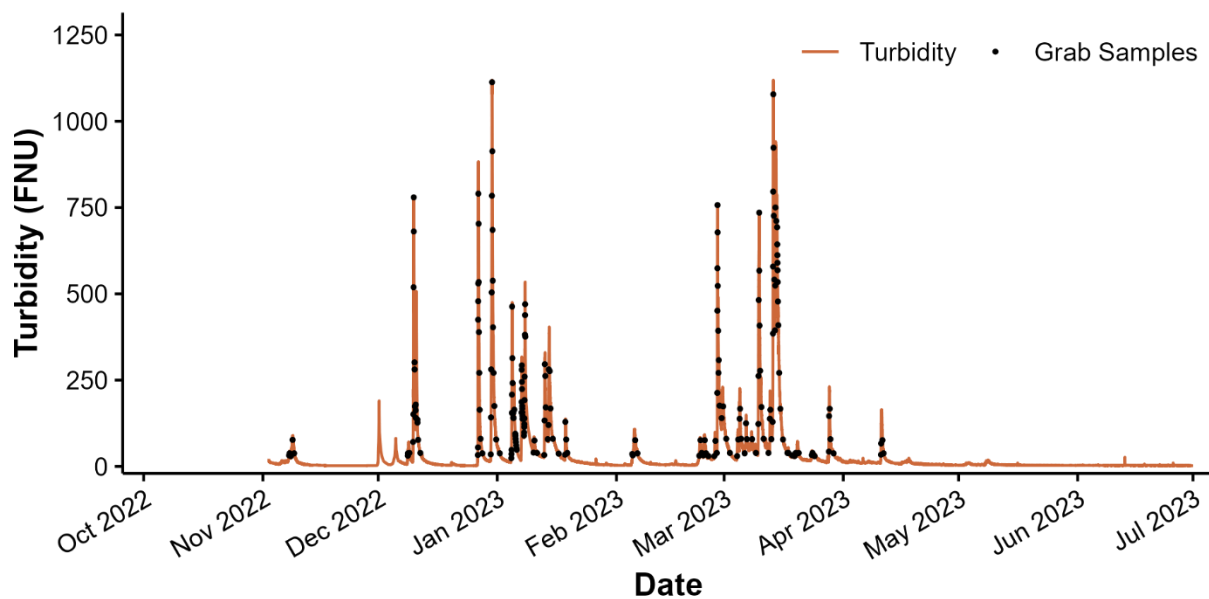
Figure 6. Continuous Time-Series of turbidity collected by the instream DTS-12 sensor and timing of turbidity threshold grab samples at the McCloud Creek TTS station during the 2023 WY.

A DTS-12 sensor was used to measure continuous turbidity (FNU) at 10-minute intervals throughout the 2023 WY (Figure 6). Where turbidity values were missing or erroneous due to equipment failure or measurable range exceedance, values were estimated using stage-based regressions, values derived from grab samples (when possible), or interpolated using adjacent valid data. The type of estimates used for missing or erroneous data was noted and can be found in the 'Data Management' tab in the electronic data file (Appendix A).

A total of 239 water samples were collected (207 automated and 32 manual) during the 2023 WY. Paired manual grab samples were always taken if the station turbidity read >30 FNU and taken opportunistically when FNU was <30 during a site visit. These were collected using the ISCO sampler with a manual override and were primarily used as laboratory quality control samples. The collection times for manual and automated (i.e., turbidity threshold) grab samples were compiled and overlaid on the continuous turbidity time series for the 2023 WY (Figure 6).

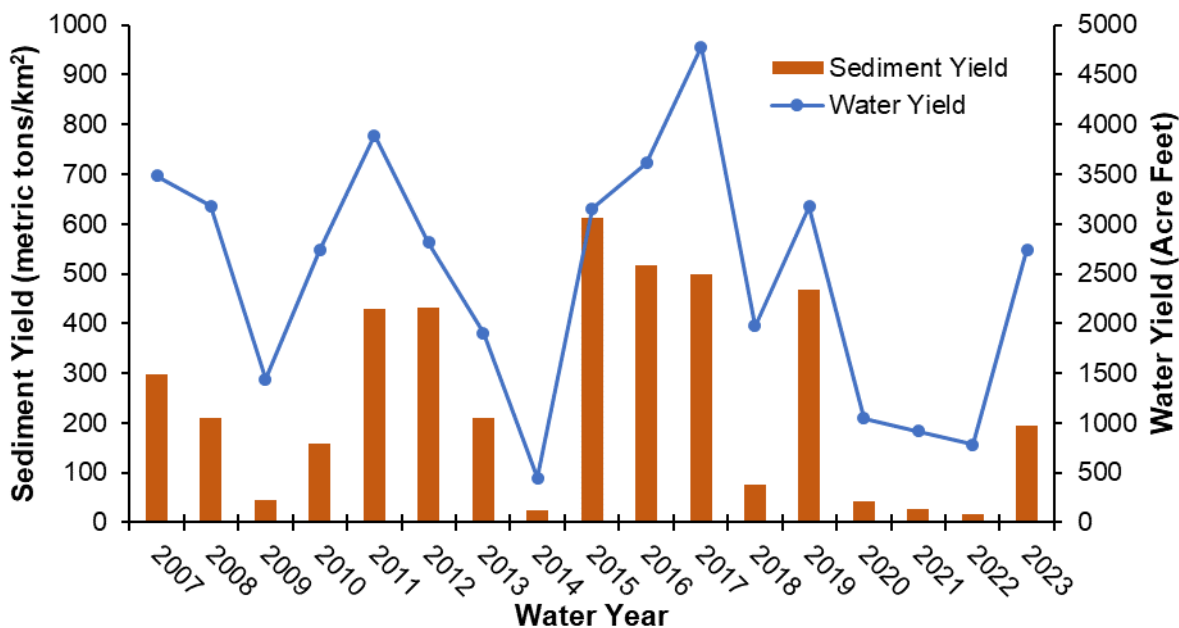
Figure 11. Annual sediment yield (metric tons/km²) and water yield (Acre Feet) estimates for the McCloud TTS monitoring site for water years 2007 through 2023.

monitoring years 2007 through 2023 are strongly and positively correlated ($\rho = 0.84$, Figure 11).

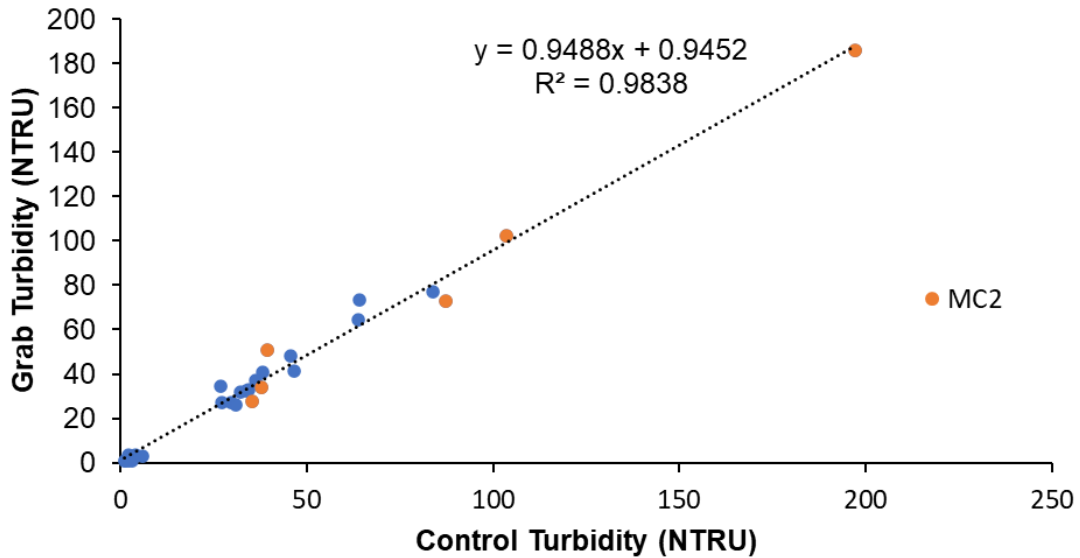
Figure 11. Relationship between lab turbidity (NTRU) of paired control and grab samples collected across 12 sites during the 2023 WY, with those samples collected at the McCloud Creek TTS station indicated by orange points.

To evaluate the consistency of laboratory processing for turbidity and SSC, GDRCo performed a QA/QC test using paired grab and control water samples collected during site visits. Grabs are taken back to be immediately processed in the lab while controls are stored in a refrigerator until the end of the water year. Hydrochloric acid is added to each control sample that is placed in the refrigerator to help preserve it for later processing. At the end of the water year a random subsample of grabs and paired controls are processed for turbidity and SSC to assess lab repeatability. This subsample resulted in 6 of the 16 paired manual samples from McCloud to be selected. These samples were collected during routine site visits, using the ISCO pump sampler. The relationships between the paired grab and control samples for turbidity and SSC were established (Figures 11 and 12, respectively) using data from 12 TTS sites that GDRCo operates including the McCloud Creek station. The relationship for lab turbidity was linear and strong ($R^2= 0.984$); and produced no outlier data, indicating that the turbidity laboratory process produced nearly identical values between paired water samples. The paired samples for SSC also produced a linear relationship ($R^2= 0.762$) and contained two outliers. One outlier pair, taken at McCloud Creek TTS station, indicated that there was sand on the grab sample filter while the control sample did not have sand and was slightly burned which would result in the observed discrepancy in SSC. Another outlier grab and control pair, taken at MSAP, had no clear reasoning for the discrepancy in SSC.
