**ANNUAL REPORT FOR MONITORING OF SUSPENDED
SEDIMENT CONCENTRATIONS AND TURBIDITY DURING
THE 2016 WATER YEAR IN MCCLOUD CREEK,
HUMBOLDT COUNTY, CALIFORNIA**

**Pursuant to:
Monitoring and Reporting Program (MRP)
Order No. R1-2012-0088**

Green Diamond Resource Company
Korbel, California

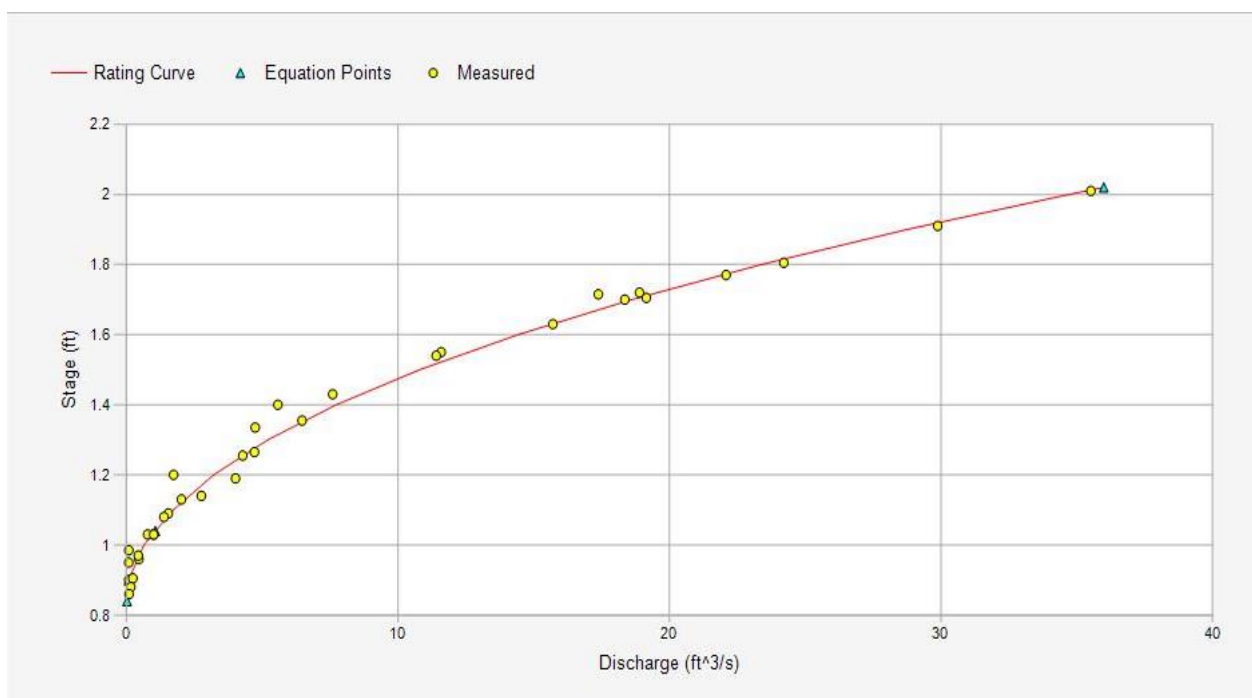
Figure 2. Discharge-stage relationship for WY 2016. This graph only includes the range of stage values that were measured in the field.

During the 2016 WY, GDRCo personnel collected 34 velocity measurements, using a current meter, and associated stage readings on the staff plate. Using Aquatic Informatics' rating development tool (Aquarius, 2016), we used a composite fitting technique (McCuen and Synder, 1986) with a breakpoint selected at 1.04 feet of stage height to develop a rating curve for WY 2016 between discharge and stage (Figure 2). The rating curve is a compound curve consisting of two segments, one for low flow conditions (section control) which is controlled by small gravels that often move during storms and one for medium flows (channel control) which consists of a larger substrate that shifts less frequently. This breakpoint was selected because it is thought to be the division of the section and channel control. At stages ≤ 1.04 feet, most discharge measurements included verticals with measured velocities < 0.25 fps ($n = 9$), values at the low end of the rated measurement capacity of the USGS Pygmy (Model 6205) flowmeter. Measurements within this range displayed relatively high variance.

In addition, at stages ≤ 1.04 feet, discharge measurements appeared to shift from the base rating curve in the latter part of the water year. This is likely due to a change to the channel morphology at the monitoring site during or after a major storm event. It is difficult to identify the exact timing of the shift, as these low stage conditions only occurred during the beginning and end of the water year.

At stages > 1.04 feet, in the channel control, velocities measured within each discharge measurement were within the acceptable range of rated flowmeter measurement capacity. Measurements within this range display less variance and appear to fall onto the same rating curve throughout the water year. These composite cut points provided the best fit of data in each of the two segments.

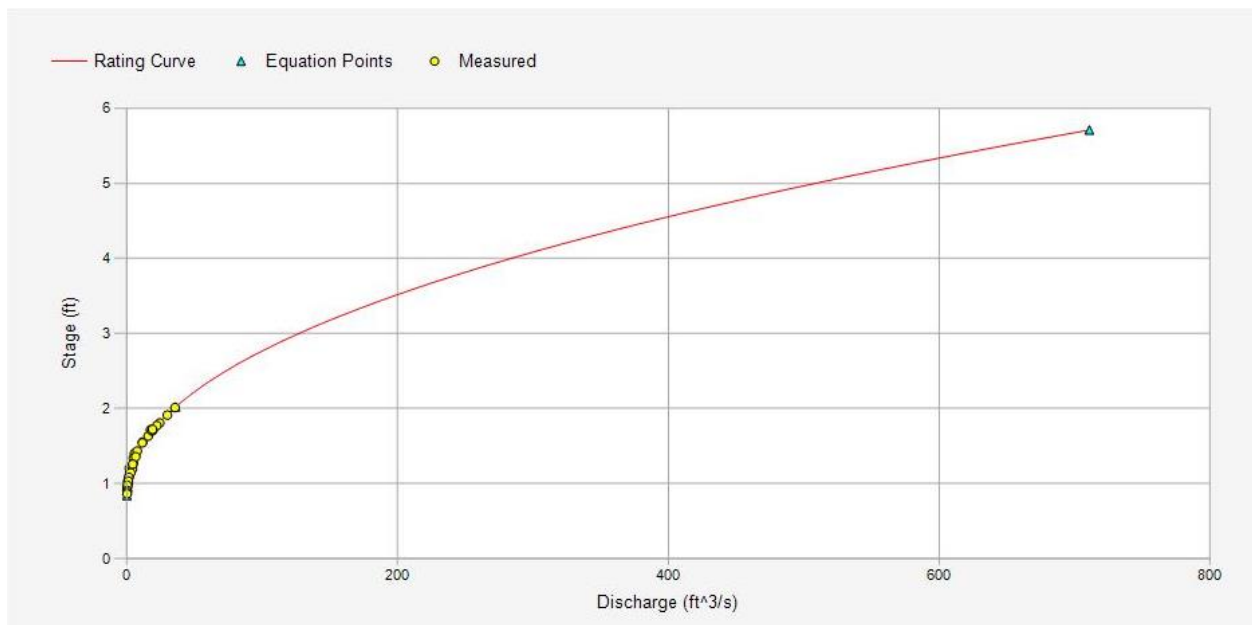
Figure 2.1. Discharge-stage relationship for WY 2016. This graph includes the range of stage values that were measured in the field (Yellow Circles) and an estimated maximum value based on the Gauckler-Manning formula (Blue Triangle).

Discharge values estimated from stages greater than the maximum measured discharge (i.e., stage > 2.02 ft) for the 2016 WY were extrapolated using the Gauckler-Manning formula (Manning, 1891) and the rating curve to produce an expanded relationship between discharge and stage to include all continuous stage data (Figure 2.1). These data should be used and viewed with caution without empirical support. Efforts were made during this and previous WYs to obtain measurements at higher stages but site access was prohibited at these times because access required wading across SF Elk River, which was unsafe at high flows.

Continuous discharge for the 2016 WY (Figure 3) was estimated using the regressions calculated in AQUARIUS from the stage-discharge relationships that include extrapolated values (Figure 2.1). The estimated peak discharge for McCloud Creek during the 2016 WY occurred on January 17 and was ≈ 592 cfs (stage = 5.35 ft). Due to the safety limitations involved in wading across SF Elk River during storm events, discharge measurements at the McCloud TTS site were not taken at stages > 2.02 feet (≈ 36 cfs) during the 2016 WY. Despite this limitation, 95.8% of the stage measurements recorded during the 2016 WY were within the range of measured discharges and considering the strong relationship between stage and discharge, extrapolated discharges within this range have high confidence. The extrapolated discharge values that exceed the range of empirical values have a high uncertainty given the lack of discharge measurements for stages greater than 2.02 ft.

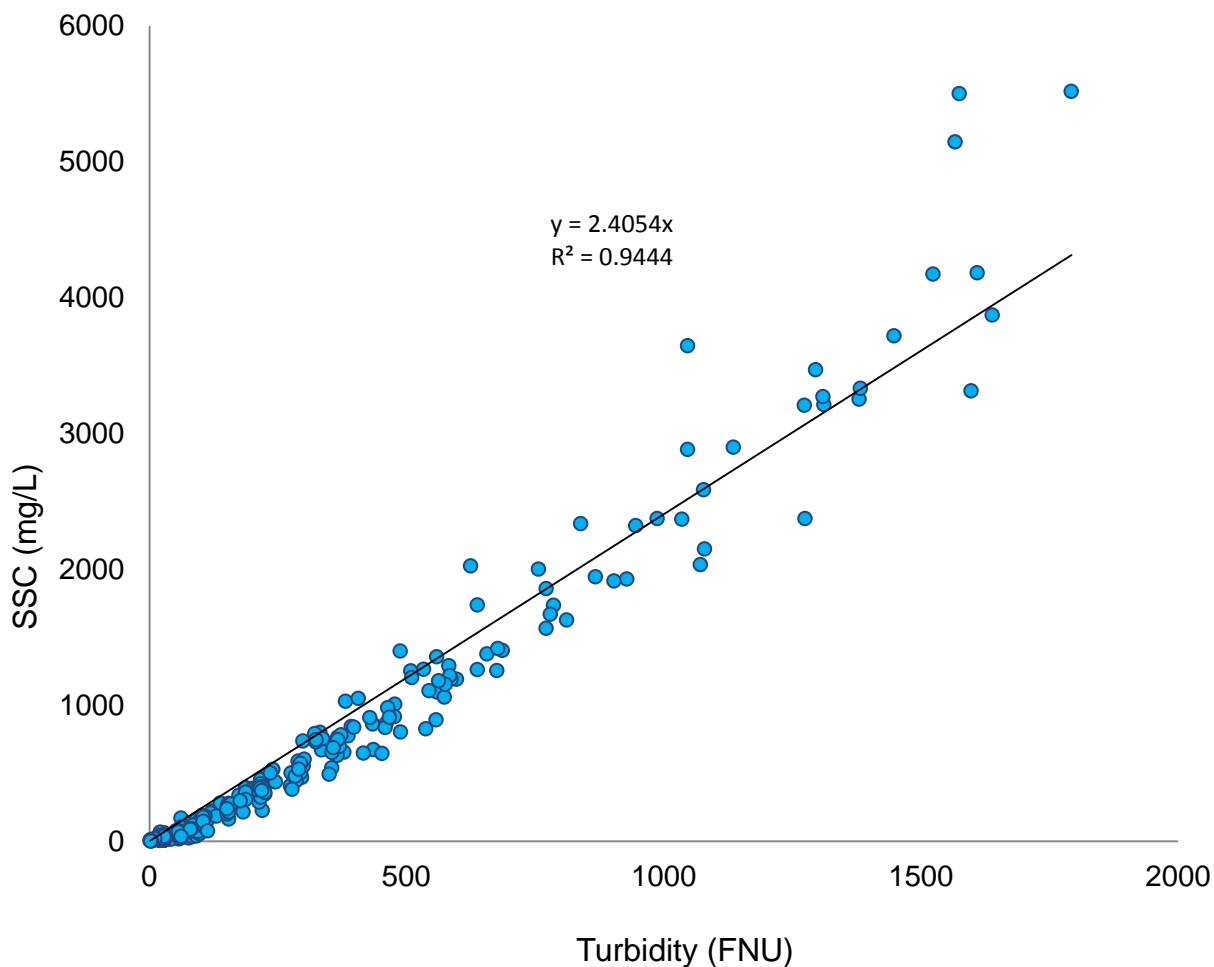
Figure 7. Relationships between turbidity and SSC for the McCloud Creek TTS station during the 2016 WY.

The relationship between suspended sediment concentration (SSC) (mg/L) and turbidity (FNU) from manual and turbidity-threshold ISCO samples for the 2016 WY was established (Figure 7). Our assessment of this relationship was relatively simplistic and a better fit of these data may be possible through an assessment for additional relationships.

Though generally linear, the relationship between SSC and turbidity can change over the course of the year either between or within storm events (Lewis 1996). In order to establish stronger relationships we analyzed different ranges of turbidity, individual storm events, and between rising and falling limbs of the hydrograph. These rating relationships were broken into twelve different ratings (Table 4) with linear relationships that directly relate turbidity, in FNU, to SSC. We decided to analyze SSC with FNU, rather than NTRU to avoid having to convert the entire FNU data-set into NTRU before deriving a continuous SSC data-set. An analysis of these data is recommended to estimate the most accurate annual sediment load.

We have seen from our data (Figure 7) that the relationship between field turbidity (FNU) and the coincident laboratory suspended sediment concentration (SSC) is dynamic. In 2016, Green Diamond purchased Aquatic Informatics' Aquarius Time-Series software to better analyze this relationship, as well as for other data-management goals. Using this software, we identified twelve different turbidity-SSC relationships (Table 4), which when extrapolated over time provide us with a continuous data-set of derived SSC. The single, simplified linear relationship provided in this report, and years prior, should be used with caution if deriving a sediment load.

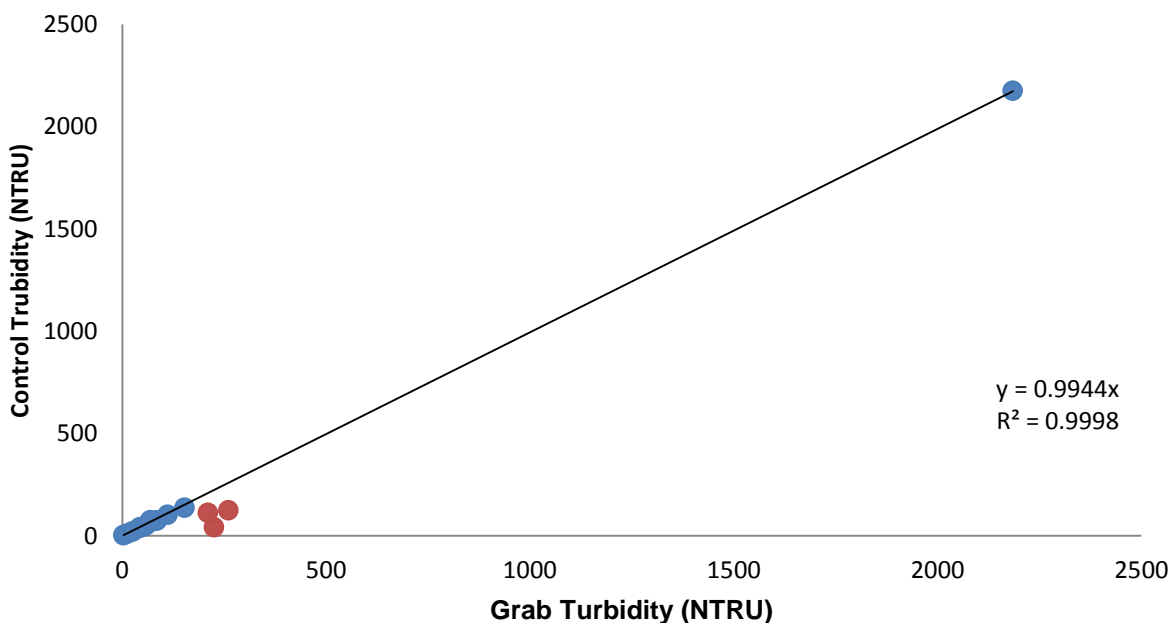
Figure 8. Relationship between water turbidity of paired control and grab samples (blue circles) collected at the McCloud Creek TTS station during the 2016 WY. The red circles represent outliers that were excluded from the analysis.

The relationships between the paired samples for turbidity and SSC were established (Figures 8 and 9, respectively). Three outliers were observed in the dataset for both relationships and were excluded from this analysis. The specific reason for the deviation of these samples from the observed relationship is unclear. Furthermore, the processing at the end of the WY (control samples) appears to be much more consistent with the expected result. Given the huge difference in both turbidity and SSC for these samples, it seems likely that they were mixed up during initial laboratory processing rather than incorrectly measured. Green Diamond monitors eleven other TTS sites, so it is possible that these samples represent another location entirely. A high intensity of storms during the El Nino winter overwhelmed the laboratory and these samples appear to be erroneous. The relationships for both turbidity and SSC among the remaining 16 samples were linear and strong; indicating that laboratory processing produced nearly identical values between paired water samples. Efforts will be made to better manage the laboratory to ensure samples are properly labeled and processed accordingly.

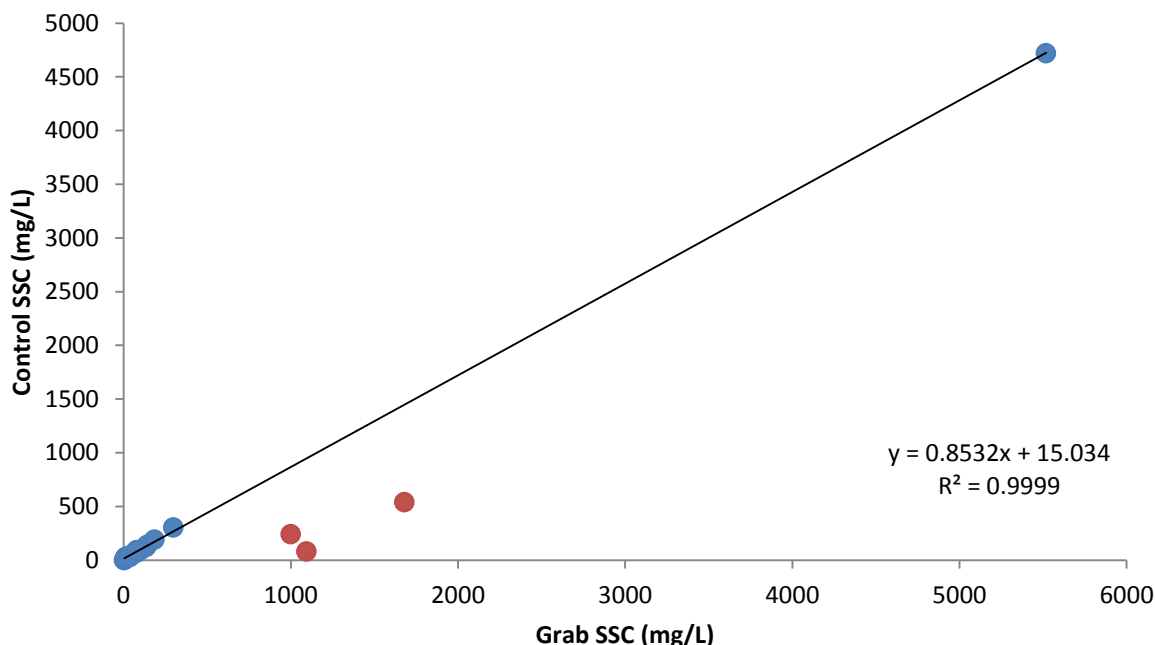
Figure 9. Relationship between suspended sediment concentration (SSC) of paired control and grab samples (blue circles) collected at the McCloud Creek TTS station during the 2016 WY. The red circles represent outliers that were removed from this analysis.
