RE: Master Inventory Report specific to GDRCO's ownership within South Fork Elk River as per the **Monitoring and Reporting Program (Order R1-2020-0001 attachment C II (D)) of Green Diamond Resource Co Forest Management Waste Discharge Requirements (FMWDR) Order R1-2020-0001.**

**RE: 2022 Completed Annual Summary Report for South Fork Elk River Order No. R1-2020-0001**

**RE: 2023 Planned Annual Work and Treatment Schedule for South Fork Elk River Order No. R1-2020-0001**

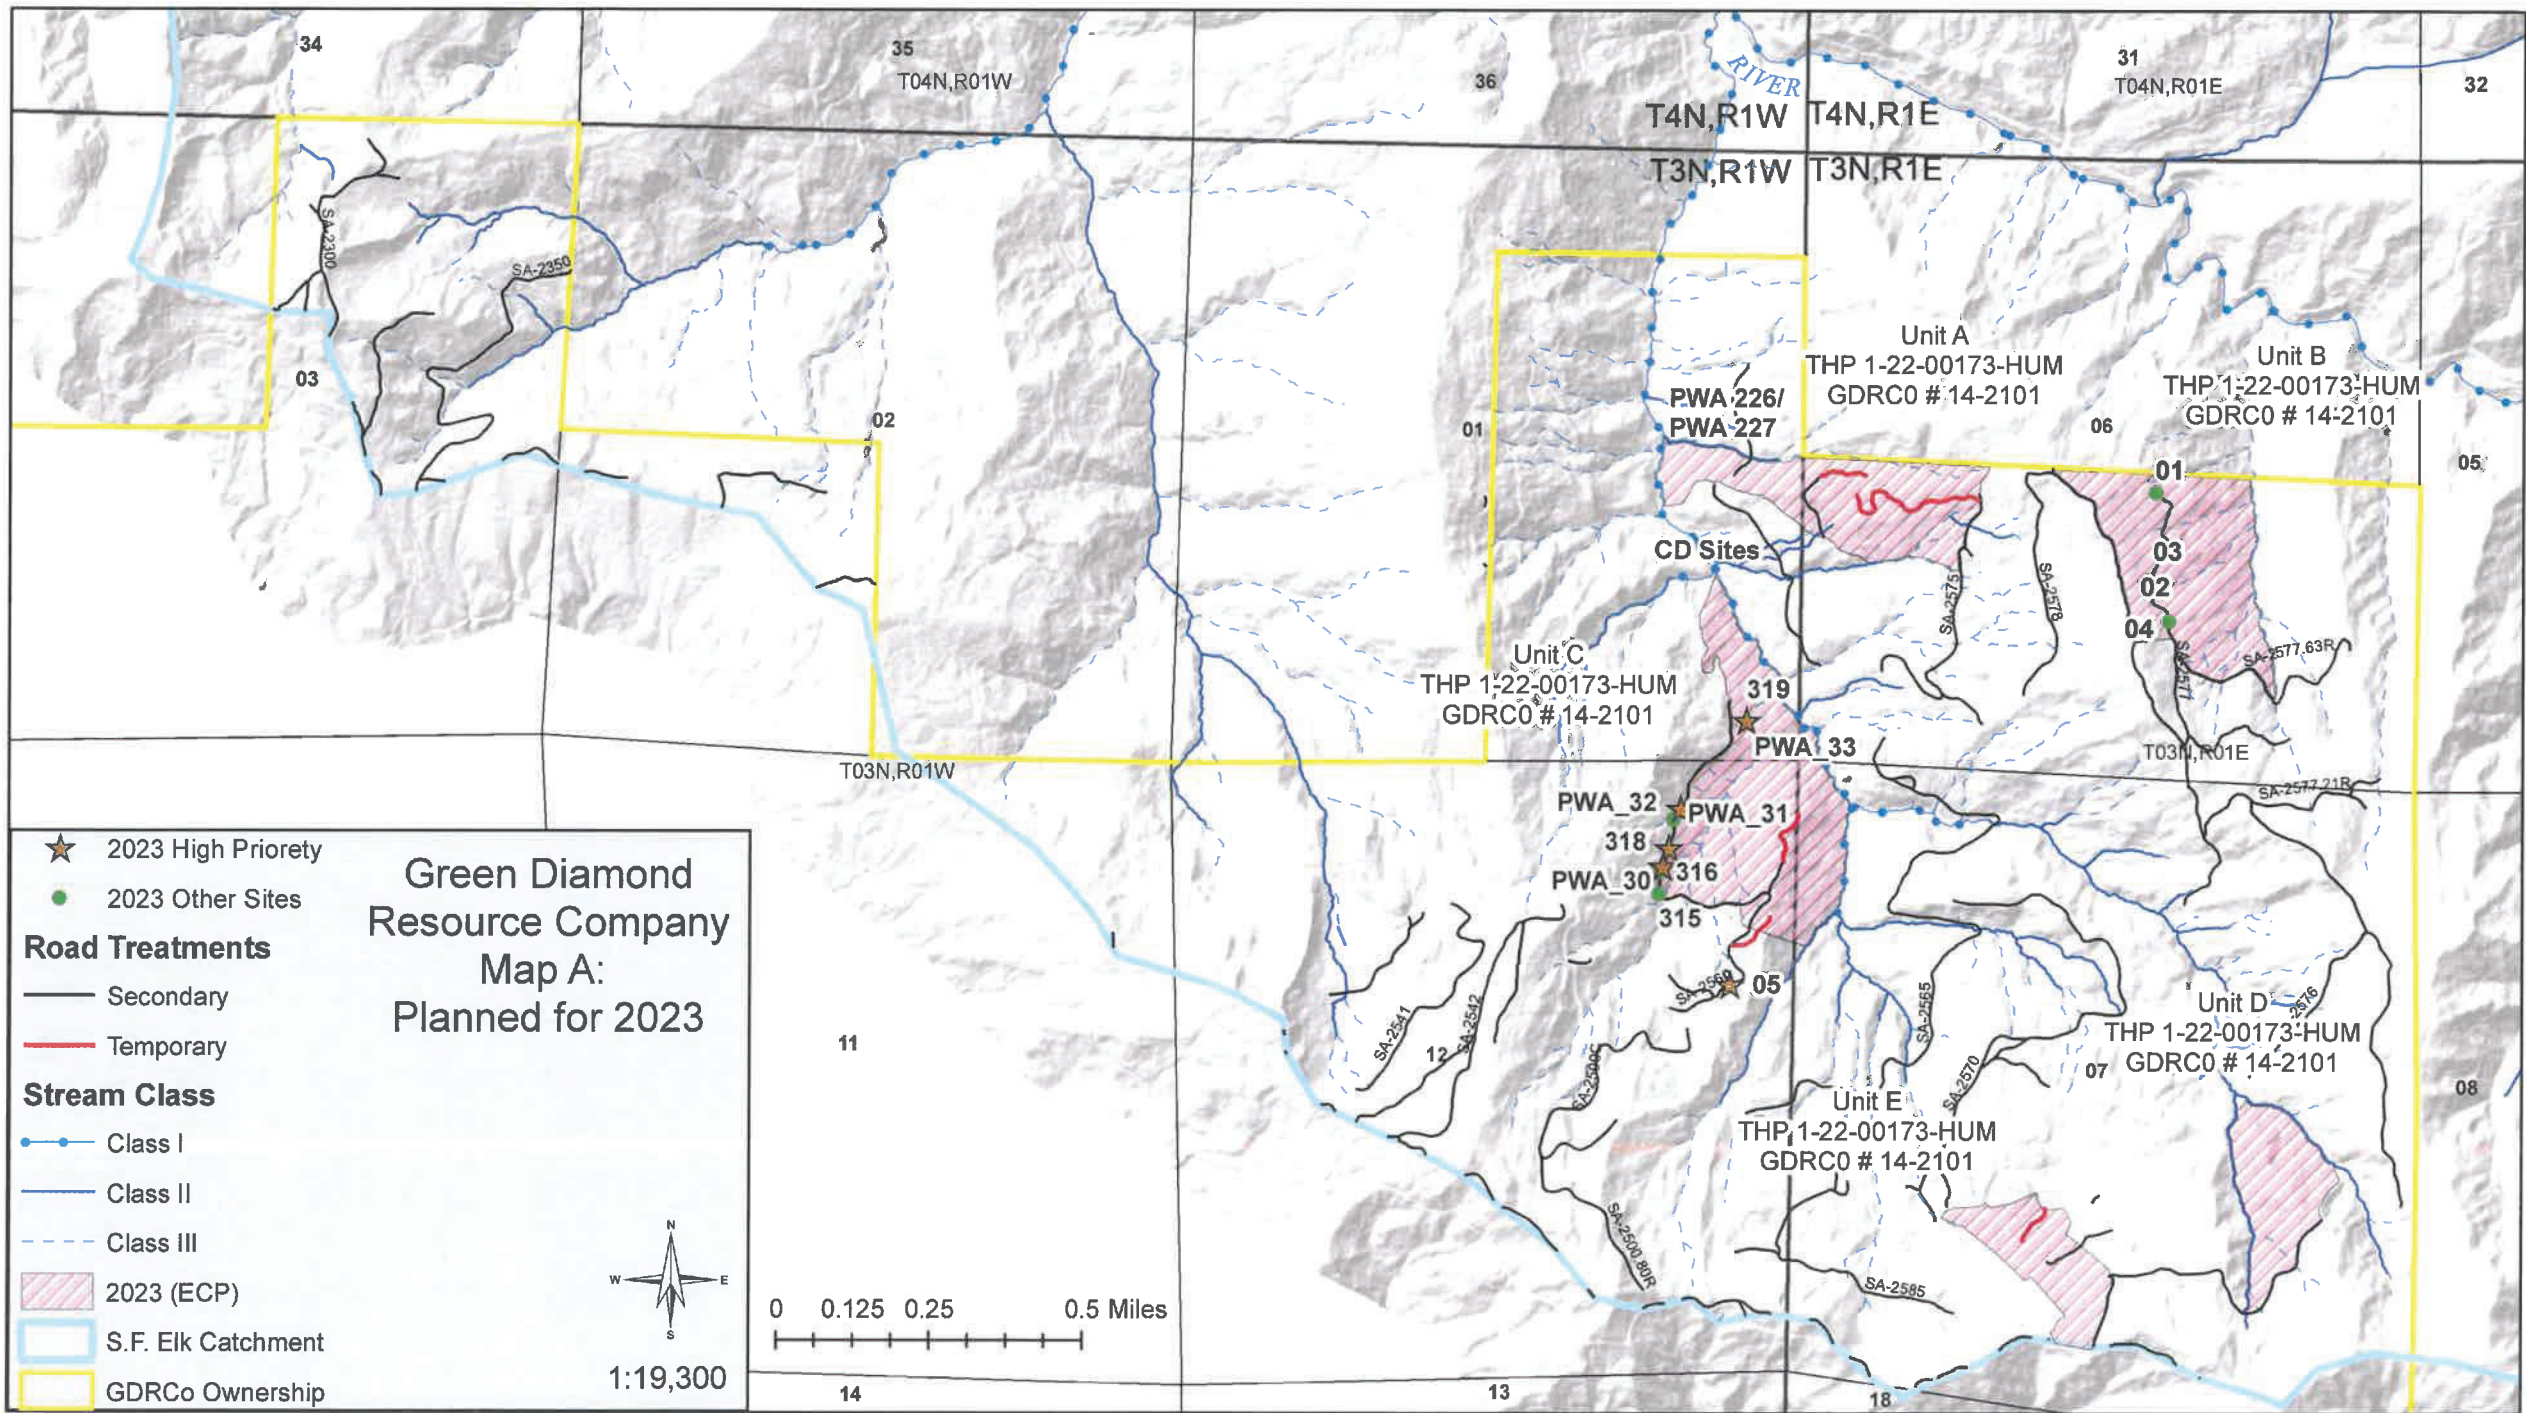
**Map A:**

Timber harvest, road construction, watercourse treatments planned for 2023 are associated with Units A-E of THP 1-22-000173 HUM. These units are mapped on attachment Map A.

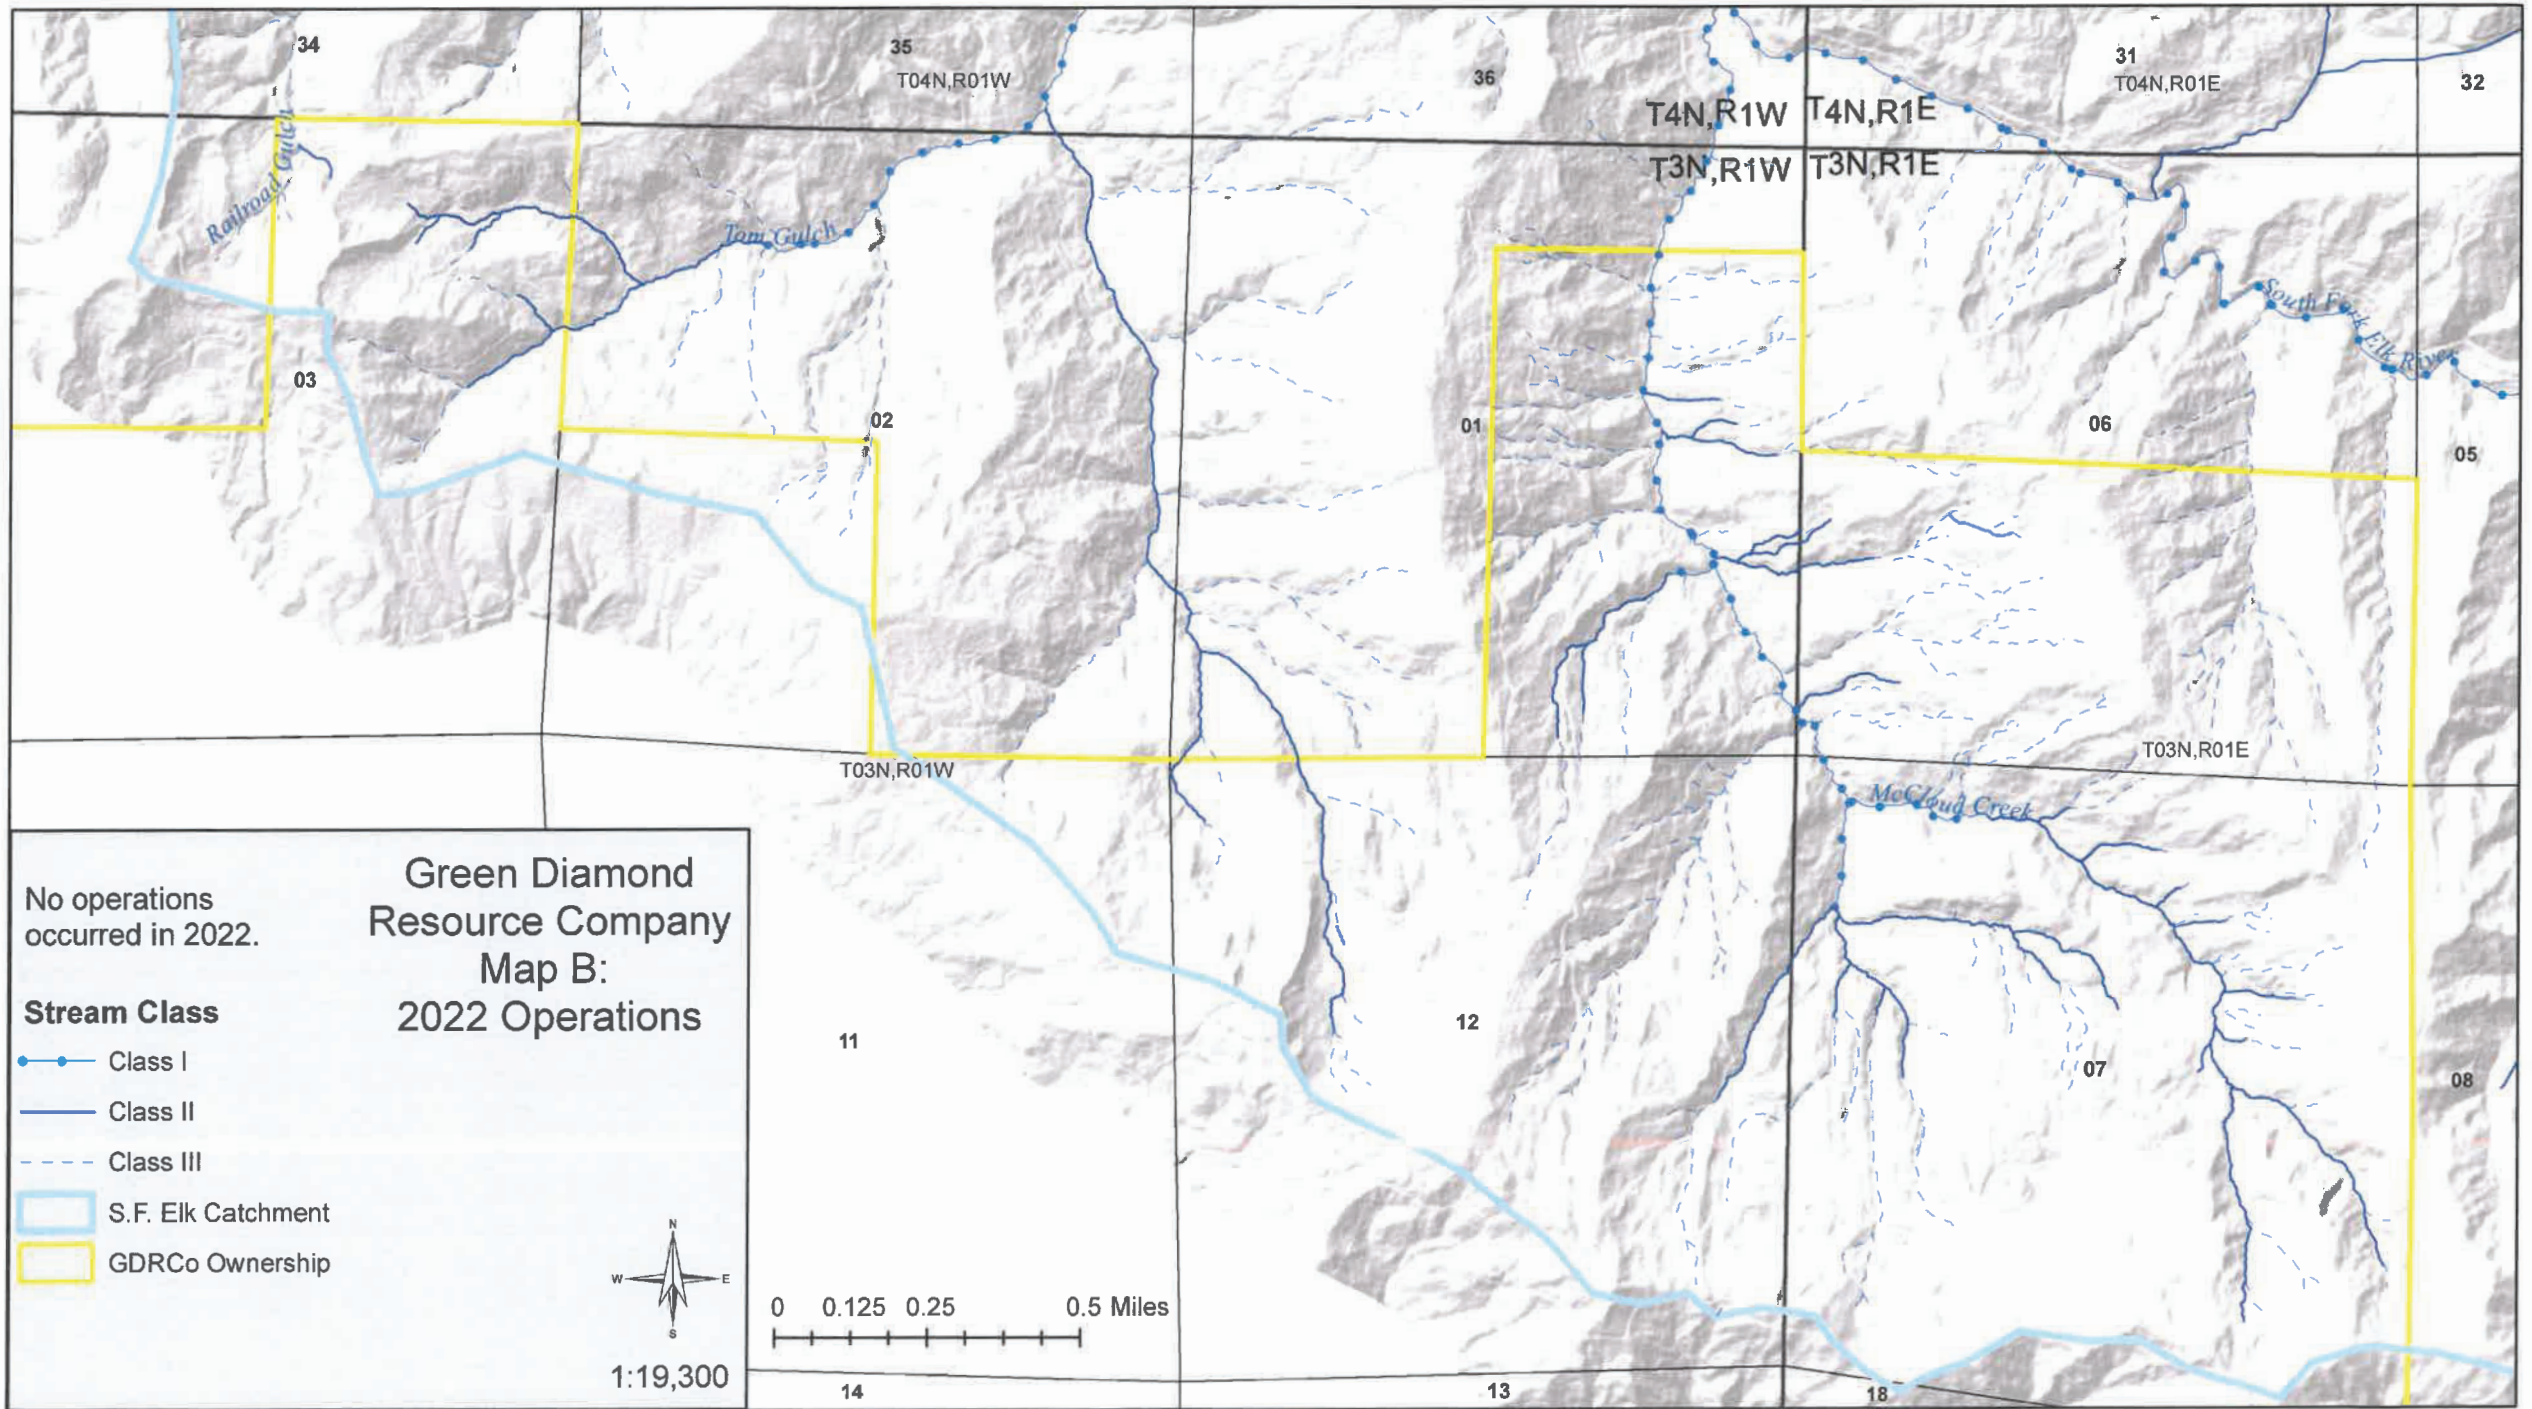
**Map B:**

Harvest units operated in 2022 are shown in orange and white stripes. No operations were conducted by GDRCo in 2022 within this drainage.
